PHASE I ENVIRONMENTAL SITE ASSESSMENT

FRANKFORT ROUNDHOUSE STATE ROUTE 28 AND BOOMER STREET, FRANKFORT, INDIANA

SME Project Number: 066340.00.04A.012

April 3, 2015

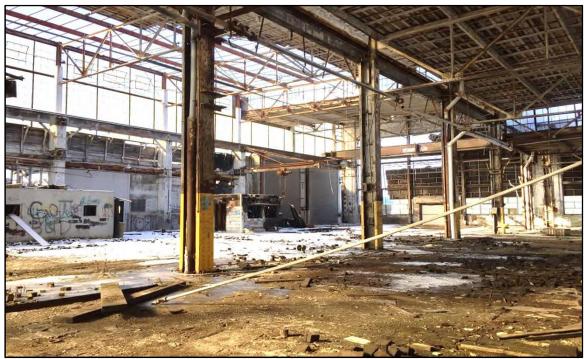
Ms. Kuhn observed pits related to locomotive maintenance located throughout the machine shop and roundhouse portions of the main facility. Oil-soaked wood flooring was present within the machine shop portion of the main facility. The potential for environmental impact associated with the oil-soaked wooden block floor in the machine shop represents a suspect REC in connection with the Property.

A burned interior modular office structure was present within the machine shop portion of the main facility. The fire did not appear to have impacted the floor or walls of the machine shop. The potential for environmental impact associated with the burned structure represents a suspect REC in connection with the Property.

PHOTO NO. 9: View of the interior of the machine shop portion of the main facility. The burned building and the oil-soaked wood flooring are visible.

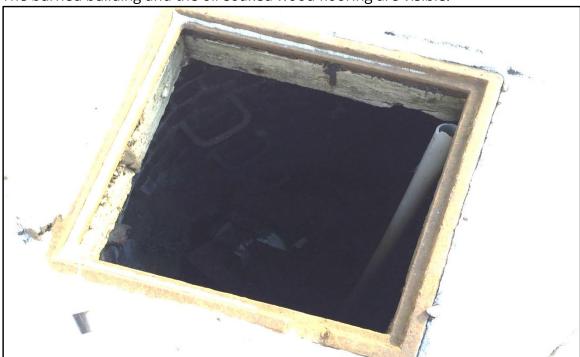
PHOTO NO. 10: View of a pit located in the machine shop portion of the main facility. These pits were present throughout the machine shop.

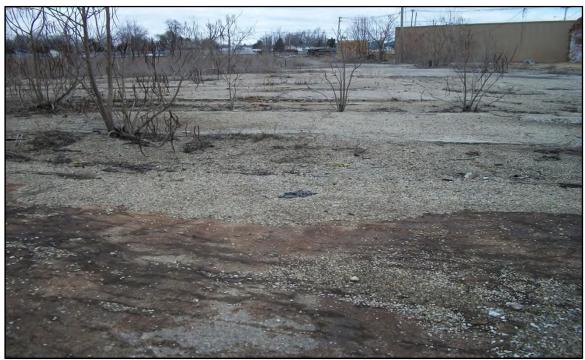
Ms. Kuhn observed monitoring wells installed in the southwestern part of the roundhouse portion. Stained concrete in the location of the demolished roundhouse was observed. The potential for environmental impact associated with the monitoring wells and stained concrete represents a suspect REC in connection with the Property.

PHOTO NO. 19: Stained concrete in the demolished roundhouse portion of the Property.

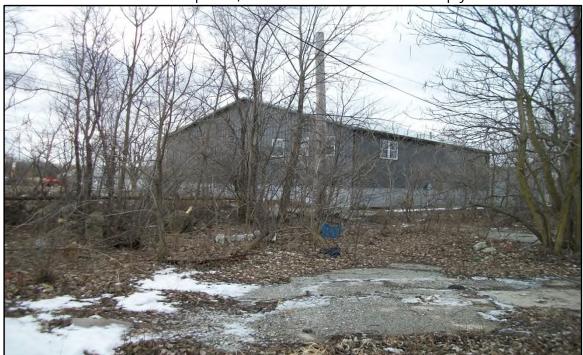
PHOTO NO. 24: Commercial storage building located south of the roundhouse parcel. Note the former foundation, concrete debris, and general refuse present on the Property.
